# Inspection Report

5XXX W Inspector Avenue

**Home Inspection Services**

**INSPECTION CONTROL NUMBER - 9015BM014****1.1 TIME & DATE OF INSPECTION**

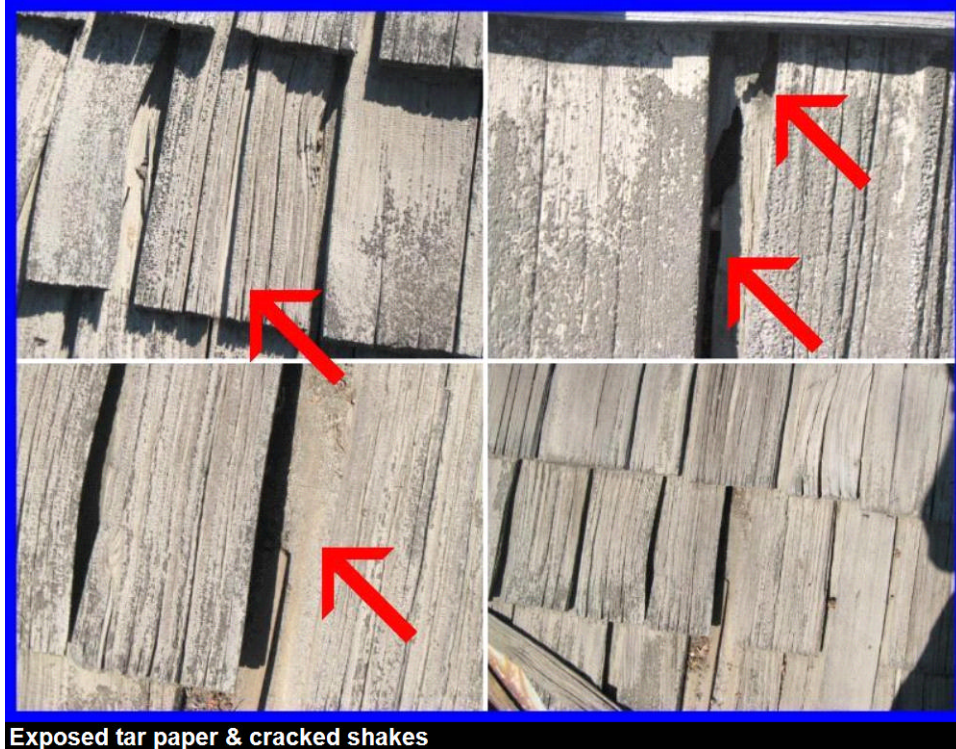
Exposed tar paper & cracked shakes

The roof covering material appears to be in poor condition and to have a remaining life expectancy of 2 to 3 years or less, assuming proper maintenance is completed as needed. The life expectancy given is the best estimate of the inspector, assuming proper maintenance. The actual life of the roofing materials used can be influenced by external sources like weather extremes, conditions caused by trees and vegetation, and mechanical damage.

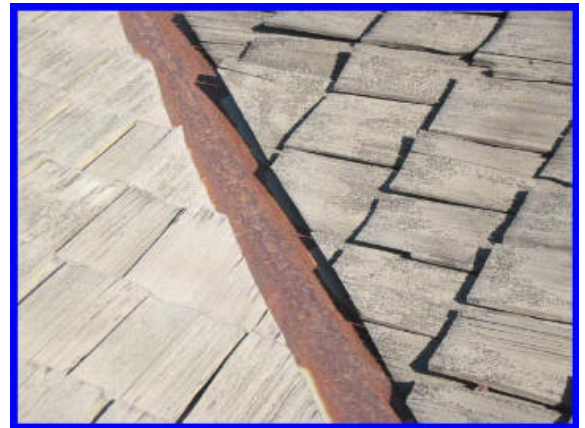
Improper installation, physical damage or other problems are present at the valley system: The valley(s) shows wear or rusting that indicates repairs or replacement is needed.

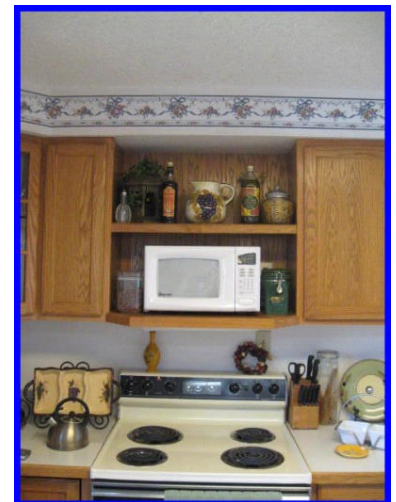
There is no fan or hood present, some type of kitchen vent fan is required in this age of home.

No kitchen vent fan present

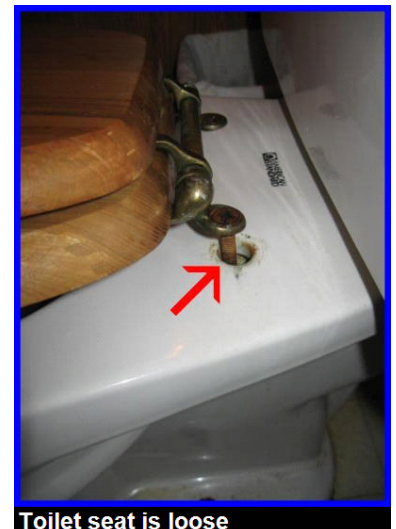
Appears serviceable. The following problems were noted at the toilet: The toilet seat is loose.

Toilet seat is loose

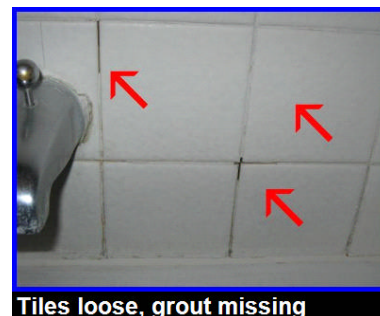
Damage and Deterioration is noted. Immediate repair or replacement of shower surround is recommended. Due to the problems viewed a qualified licensed general contractor should be contracted to make further evaluation and perform repairs or replacement as needed before the close of escrow.

Tiles loose, grout missing

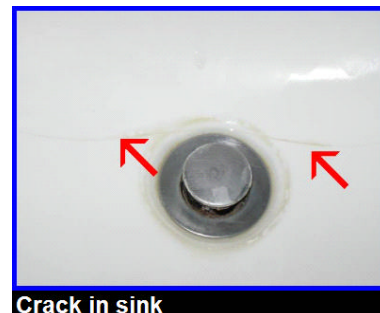
Faucet is serviceable and is performing its intended purpose. The sink is cracked, it does not appear to be leaking.

Crack in sink

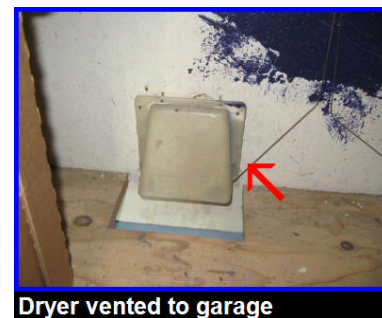
Dryer venting is provided, but it is venting to the garage. It is required that the dryer vent be vented to the outside with a back flow prevention damper at the exterior. Venting to the interior space adds excessive moisture and promotes WDO's (Wood Destroying Organisms)

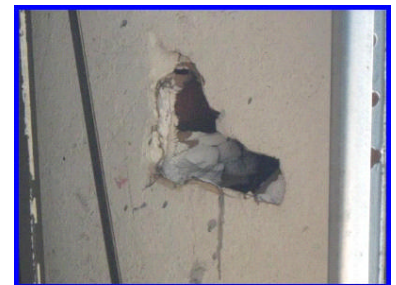
**Attention Needed - The walls show some minor condition that needs repair. Holes are not permitted in the shared wall of the home. This is considered to be a fire spread hazard. A qualified licensed general contractor should be contracted to make repairs.**

Fire spread hazard

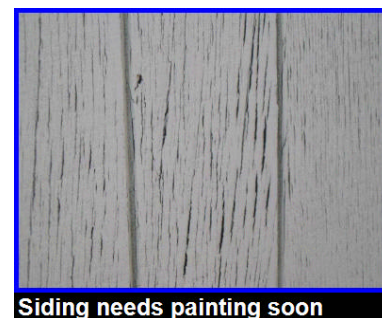
The exterior siding is a combination of T1-11 wood and brick, it appears to be in good condition. The siding needs to be re-finished or painted in the not to distant future. Peeling paint needs to be removed, joints and cracks need to be calked and entire home needs to be stained or painted.

Siding needs painting soon

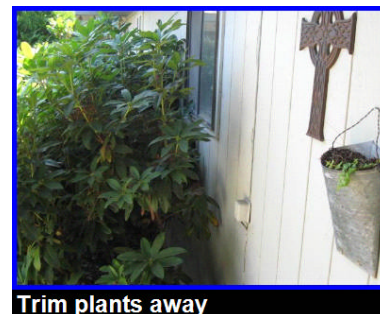
One or more problems were noted with the landscaping: Trim plants away from structure, keep minimum 6 inches away. Plant contact will cause damage or rot to the siding.

Trim plants away

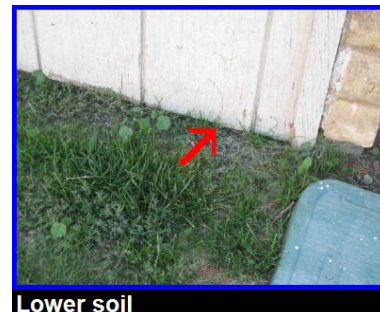
Flat site, Lower soil below siding. Grade should be 4 to 6 inches (6" is code) below any wood materials. Failure to maintain proper clearance below siding will cause wood rot and can obscure termite entry.

Lower soil

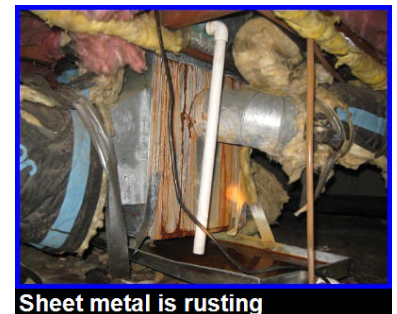
A condensate pump is installed, Condensate system is broken or improperly draining. The plenum is rusting at the crawl space from condensate water. Due to the conditions viewed above it is recommended that a licensed heating and air contractor be contracted to make further evaluation and make repairs, replacements and/or corrections as necessary.

Sheet metal is rusting

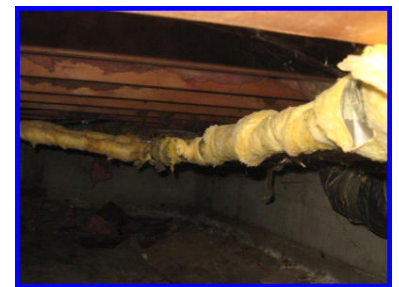
The water supply lines are made from copper metal piping, and they appear to be overall in good condition. **However, one or more problems or defects were identified at the supply plumbing lines: The supply lines are not properly supported at the crawl space or basement. It is required that supply lines be properly supported using conventional methods every 4 feet for ridged piping and every 3 feet for tubing. Improper support can cause reduction of flow due to kinking, physical damage, and breakage due to bowing.**

Piping not supported over 20 feet

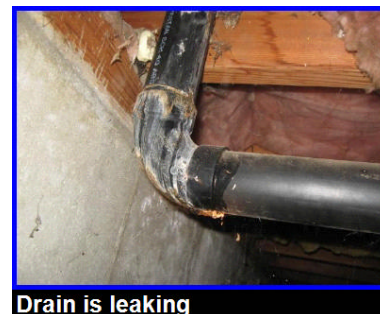
The waste lines piping of this home are made from ABS (Acrylonitrile Butadiene Styrene) black plastic piping. One or more problems were identified with the waste lines of this home: Leak(s) found, at the kitchen drain visible from the crawl space or basement.

Drain is leaking

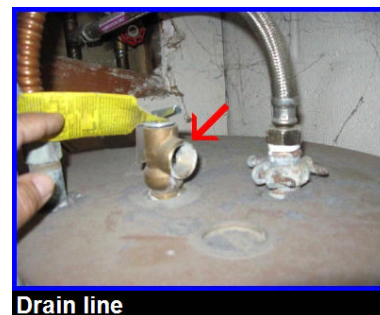
One or more problems were identified at the water heater plumbing hook-up: SAFETY HAZARD. Pressure relief valve drain line is missing or ends prematurely. I recommend this drain line be extended to a safe location to the exterior or to 6 inches from the floor.

Drain line

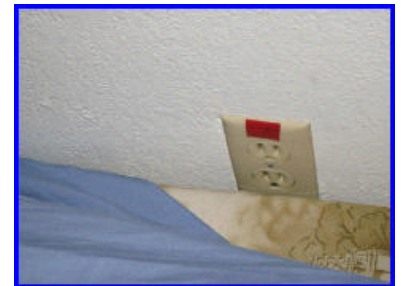
One or more electrical problems were found at this bedroom: Reverse polarity is noted, hot and neutral are reversed. Affected outlets are marked with red tape for identification purposes. Recommend that a qualified Licensed Electrician be contacted to make further evaluation and perform repairs as necessary.

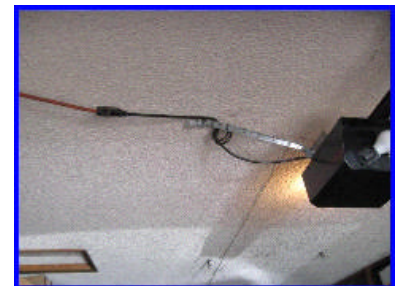
The garage door electrical is supplied with the use of an extension cord. This is improper wiring. Garage door openers are required to be plugged directly into an outlet. Recommend that a licensed electrician be contracted to install an outlet at the ceiling near the opener.

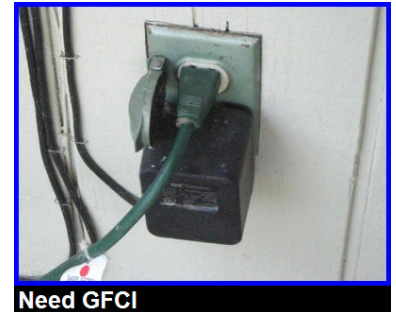
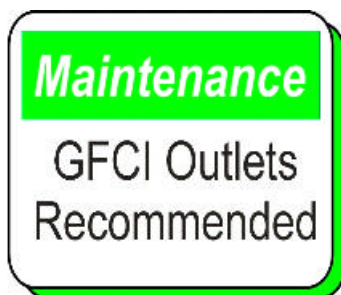
The outlets at the exterior have one or more problems: No ground fault circuit interrupter was found to be installed, Installation of these protective devices with water proof covers is, recommended as a safety upgrade by the new owner. This is not required but highly recommended.

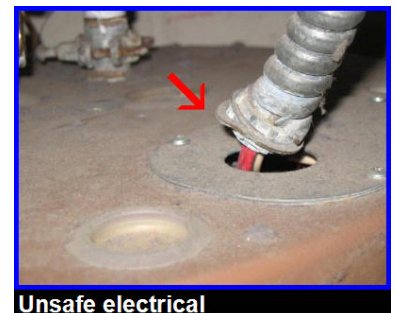
One or more problems were identified with the electrical at the water heater: Box connector needed at the electrical connection.

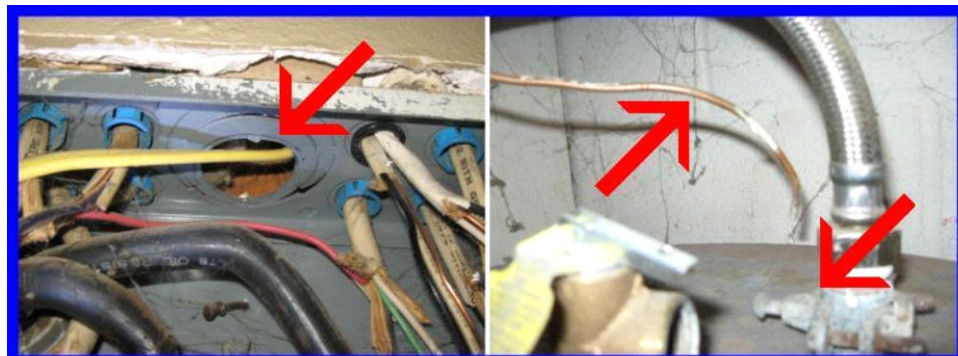
Improper electrical

The electrical panel is a circuit breaker type panel and it has one or more problems: 1) Loose clamp or inadequate ground connection at water line or ground rod, this is a shock hazard and could damage electrical systems under certain conditions 2) Knock-outs and/or box connectors are missing at interior of panel. This is a fire spread hazard in the event of an electrical fire at panel box. Fire will not be contained inside the panel box. Due to the conditions viewed it is recommended that a qualified licensed electrician make further evaluation and perform all corrections necessary to insure a safe electrical system.

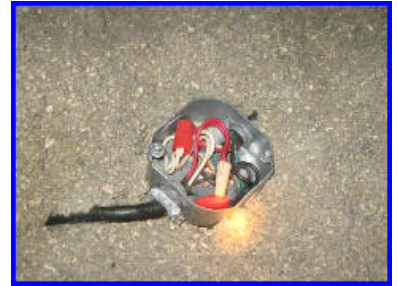
There was one or more problems with the wiring at the attic area: There is one or more open electrical junction boxes at the attic area. This is a fire hazard. All electrical boxes must be covered with proper electrical covers. Recommend that a licensed electrician be contracted to make further evaluation and perform all necessary repairs before the close of escrow.

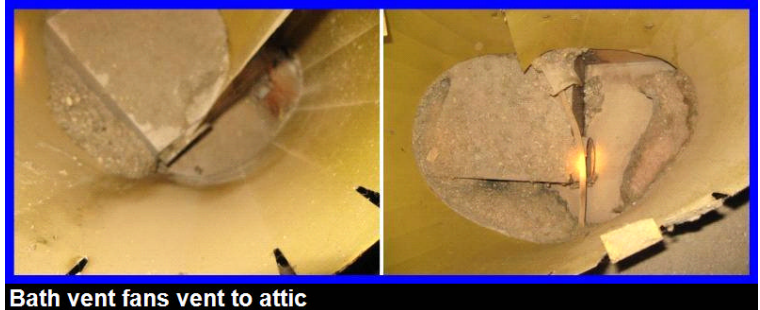
One or more bath ventilation fans vent into the attic space. This introduces moisture into the attic that must be removed from the attic. It is recommended that vents be vented to the exterior rather than the attic.

Bath vent fans vent to attic

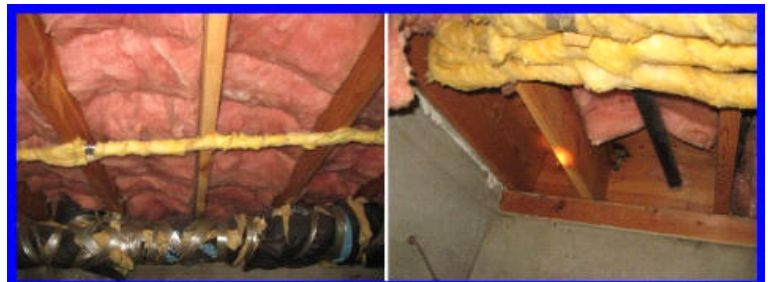
Insulation is present at the floor between floor joist and appears to be in good condition. Thickness is 6 inches or greater with an R19 rating or better. **There is one or more issues with the insulation at the crawl space of this home: There is insulation present, but it has fallen in places and needs repair. Fallen insulation greatly reduces the insulation value of the insulation system. Very small area.**

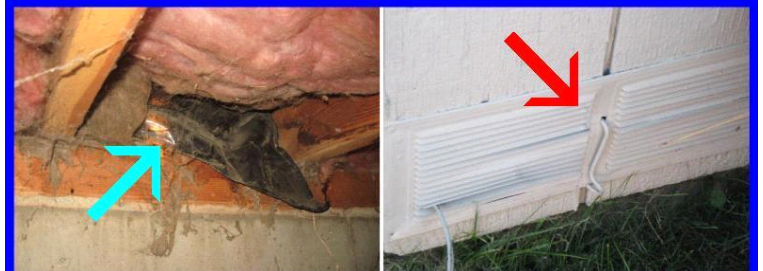
The venting at the crawl space have one or more problems: The crawl space venting appears adequate but it is plugged with dirt or debris or covered with insulation. It is required that venting be open and free flowing to allow moisture to escape from the crawl space area.

Vents closed and plugged

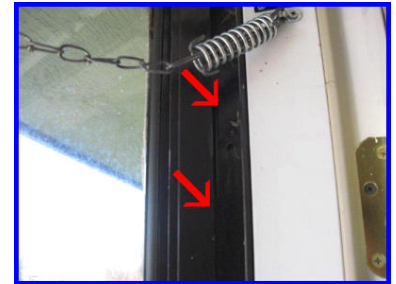
The main entry and or the storm door at the front of the home has one or more problems: The storm door is damage. The frame and or hinges are damaged or loose and need repair.

Need to re-attache

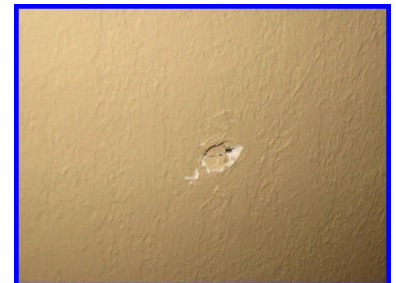
Wall damaged from door knob

Recommend that a door stop be installed to protect wall and door.

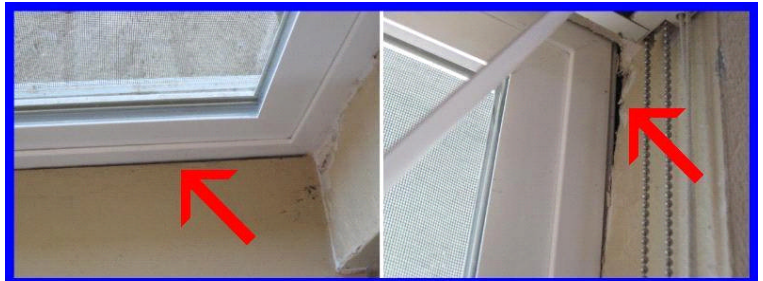
The vinyl framed windows in this room were found to have one or more problems: Installation of new windows was not completed. The window has not been caulked.

Caulking around windows is incomplete

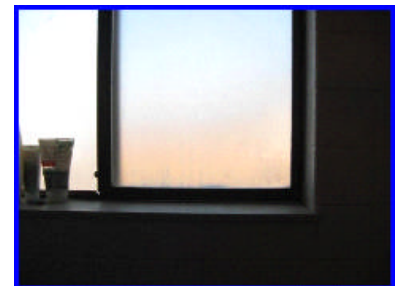
Aluminum, Insulated glass, The vacuum seal has failed, this greatly reduces the thermo values of the window and should be replaced. All areas were dry at the time of inspection. Monitor this area in the future for recurring leakage, and caulk at the interior perimeter of the window frame as needed. It is recommended that a plastic shower curtain be hung over window to prevent water intrusion at this frame or wall cavity.

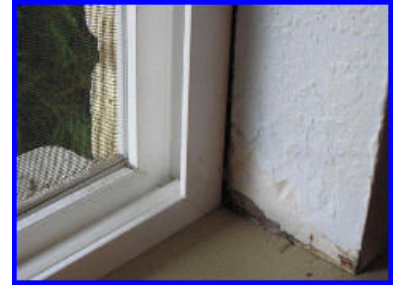
The vinyl framed windows in this room were found to have one or more problems: Installation of new windows was not completed. The window has not been caulked.
